Total Girassol Pipeline Repair System (PRS)

Client:
Total E&P Angola

Location:
Offshore Angola, Africa

Project Type:
Life-of-Field

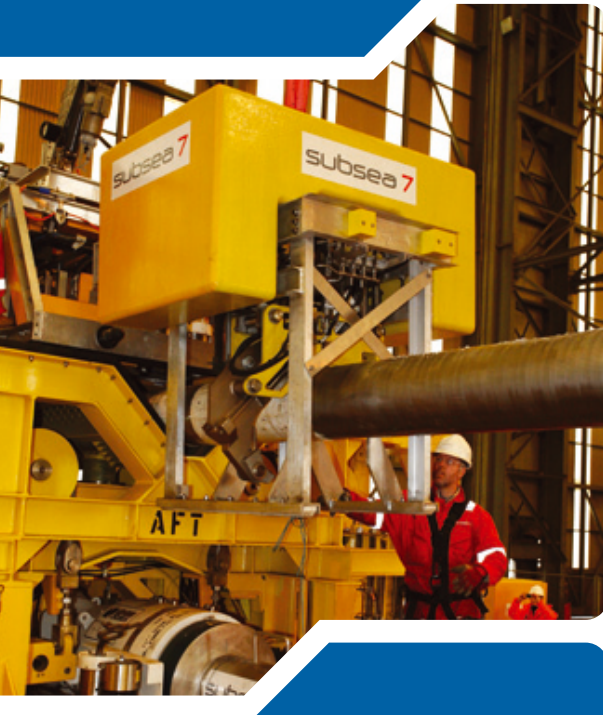
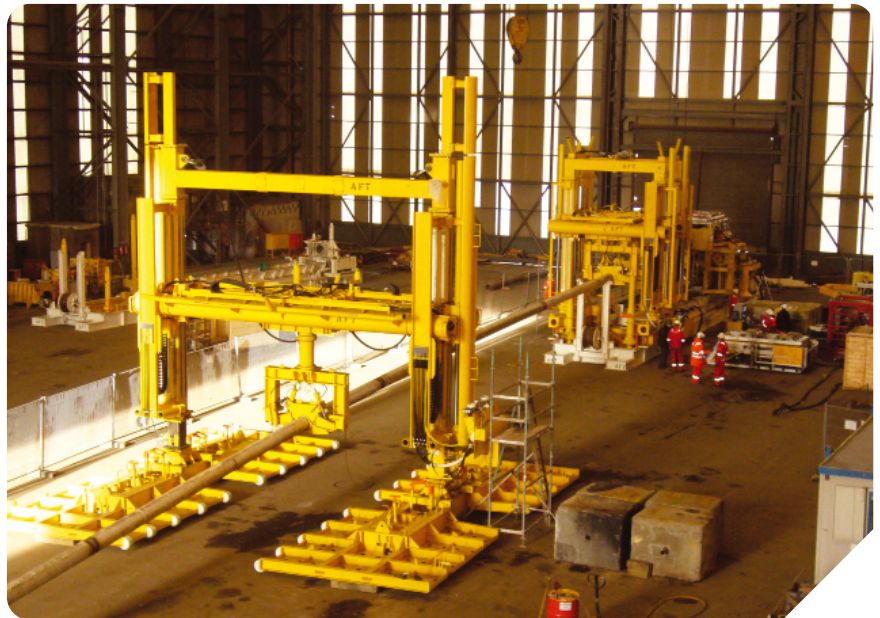
Subsea 7's winning PRS was a new concept, incorporating diverse technologies to allow the installation of the spool and associated equipment adjacent to the damaged section of pipe on the seabed. The damaged section is cut out and the pipe ends are lifted and shifted onto a structure directly above the spool ends. The pipe ends then have their coating removed, are cut to length, and lowered to align with the spool. The pipeline connectors are then carefully moved into position spanning the joint.

The majority of equipment used for the project was designed in-house by Subsea 7. The permanent PRS comprised: two large mud mats (17m x 12m), a 60m long spool deployment frame positioned across the mud mats, two end connection skids, a 36m long 12" spool piece and two mechanical connectors. A recoverable suite of tools, deployed by the vessel's crane, comprised: a pipe handling frame; connector installation tool; pipeline alignment clamp (all over 30te) and a pipeline recovery tool.
